TECHNICAL INVESTIGATION REPORT (INTERIM)

Temperature Excursion on [REDACTED] Facility [REDACTED]

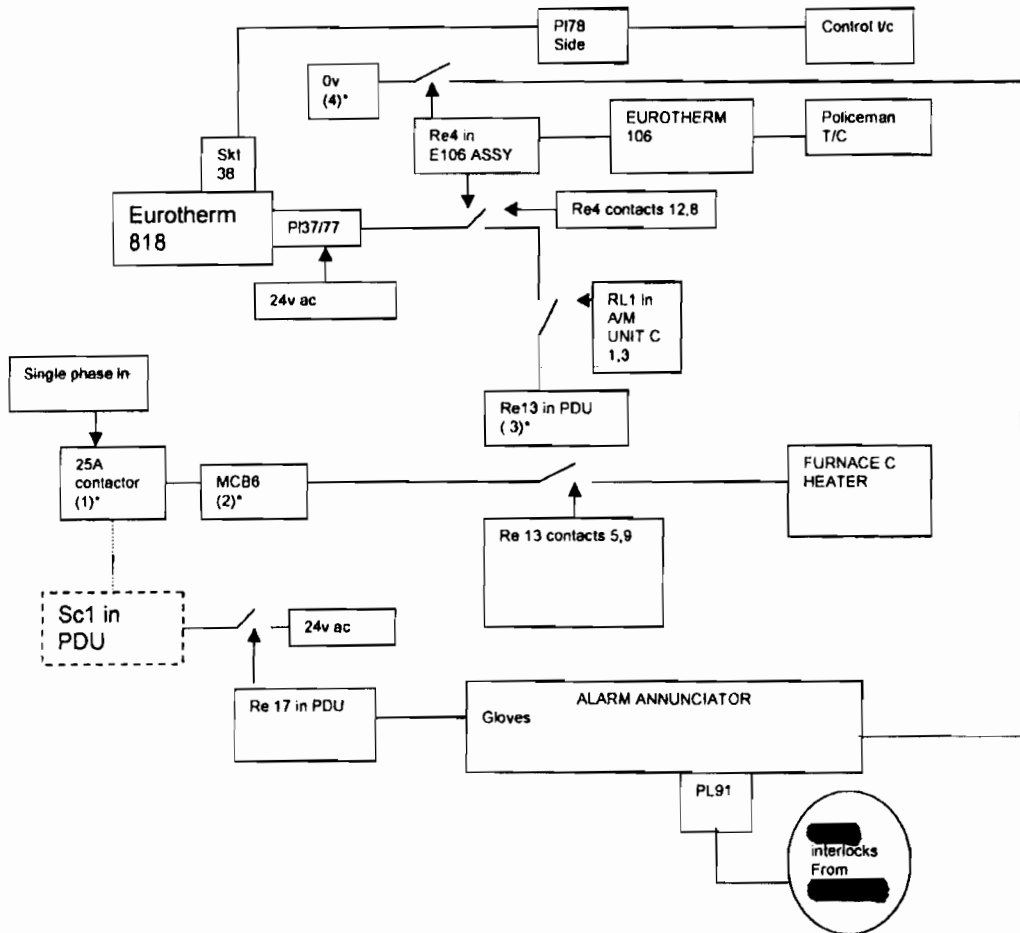
Annex A - Block Diagram of Furnace Controls

- (1)*. Power from Blue phase of 3 phase supply is fed through 25A contactor to MCB6 if certain conditions from alarm annunciator are met. ([redacted] etc)
- (2)* .If mcb6 contact is made (no overload) then power is fed to the furnace via RL13 (PDU) contacts 5,9 .
- (3)*.Control signal from Eurotherm 818 to RL13 is enabled via RL1 in auto/manual unit (signal from [redacted] controller when guard [redacted] is correct) and RL4 in EUR 106 unit (which will be made if temperature is below the threshold level set by the Eurotherm 106 controller)
- (4)*.The input from Re4 in Eurotherm 106 unit to alarm annunciator will only cause an alarm to be generated i.e. it does not act as an interlock.
