ENGINEERING - TECHNICAL INVESTIGATION REPORT

Temperature Excursion on [REDACTED] Facility [REDACTED]

Technical Investigation Report Number: [REDACTED] REP/FDA/102

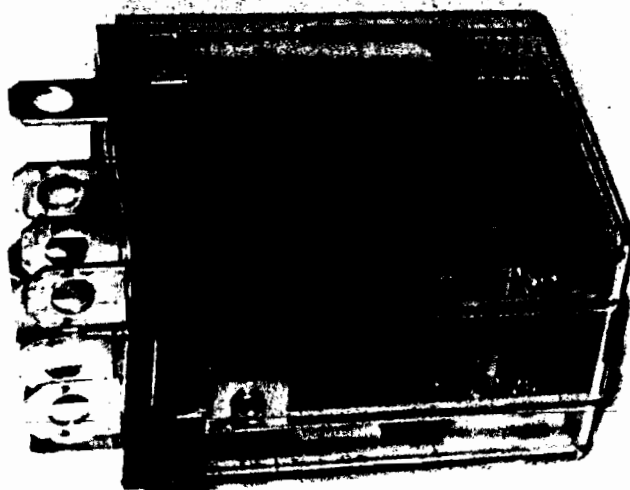
Photograph 1 of Relay 13

- On inspection of Relay 13 its transparent cover was found to be blackened and carbonised around the area of the contacts. This is indicative of contact arcing and wear. (See Annex B Photograph 1)
