AWE Fire Investigation
Key Findings and Company Responses
document
For AWE Local Liaison Committee

Introduction

On the evening of Tuesday 3 August 2010, a solvent fire broke out in an explosives production building on the Explosives Licensed Site at AWE Aldermaston.

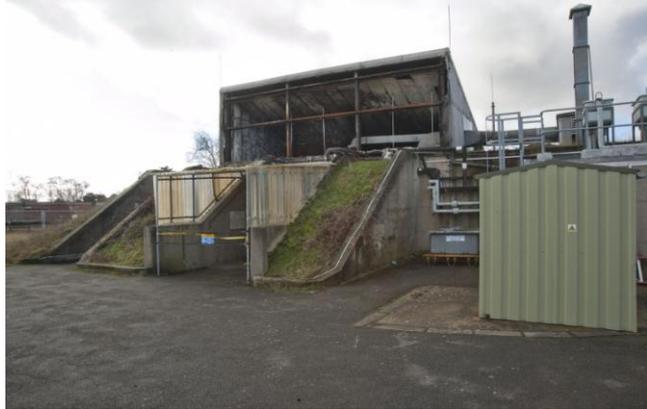
External view of the building after the fire

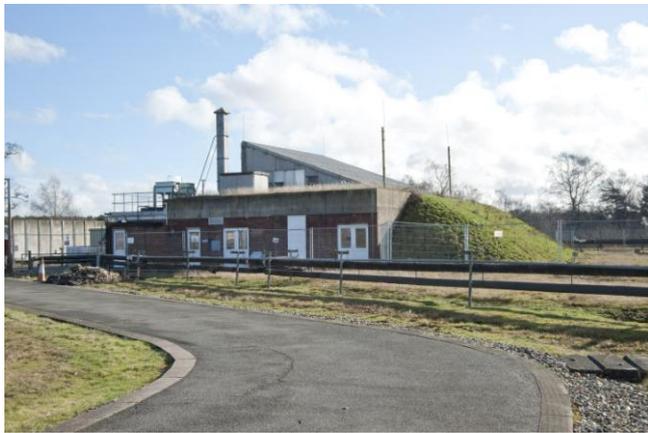
External view of the building after the fire

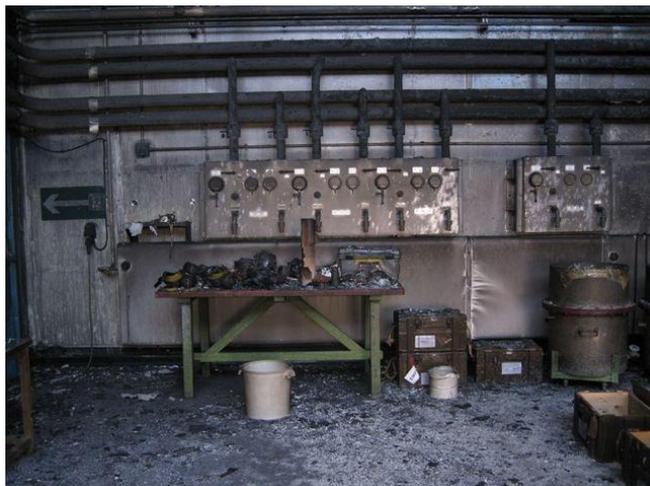
Internal view of the building after the fire

Following assessment, the fire was allowed to burn out during the night. This minimised any risk to emergency response crews and is normal practice in such circumstances. Damage was limited to equipment and materials inside the building with only minor impact on the building fabric. The fire did not spread to any adjacent areas and was confirmed to be out by 2am.
