Reference: SDE/PFG/105/07
Copy No. 2 of 20 Copies
Page No. 1 of 18 Pages
16 January 1987

TCHD ACCIDENT - WEST DEAN, 10.1.87

AWRE View

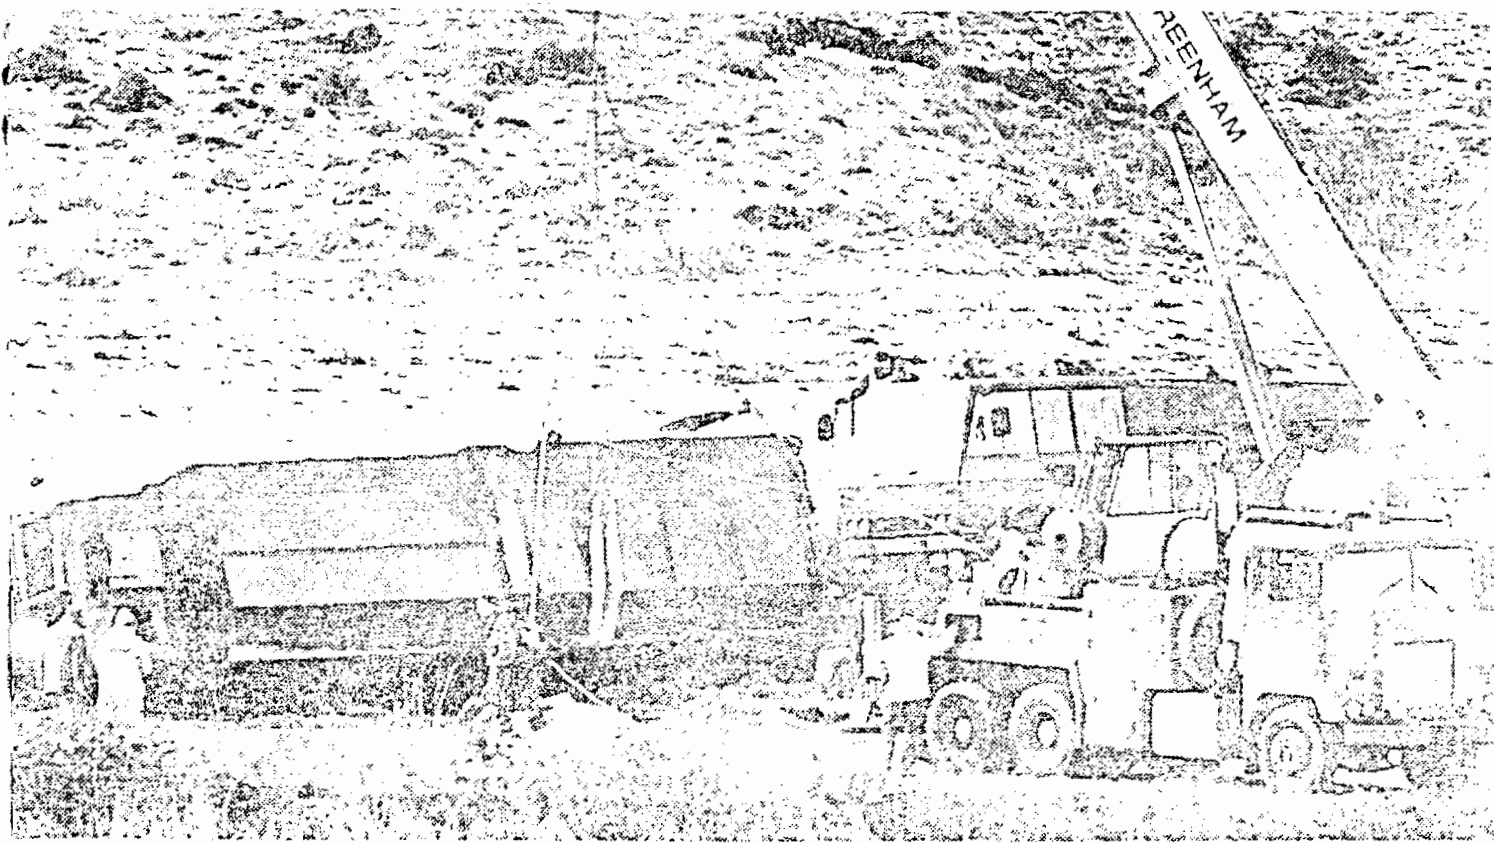
Load Carrier No. 1 on its near side in what had previously been a cornfield and was now stubble and frozen. Load Carrier No. 2 upright with its near side rear wheels on the grass verge and both its front wheels off the road and 'grounded' on its front axle area.

ue workers use a crane to lift the 20-ton transporter from the field where it lay after skidding off a country lane. (Photograph: Julian Herth)

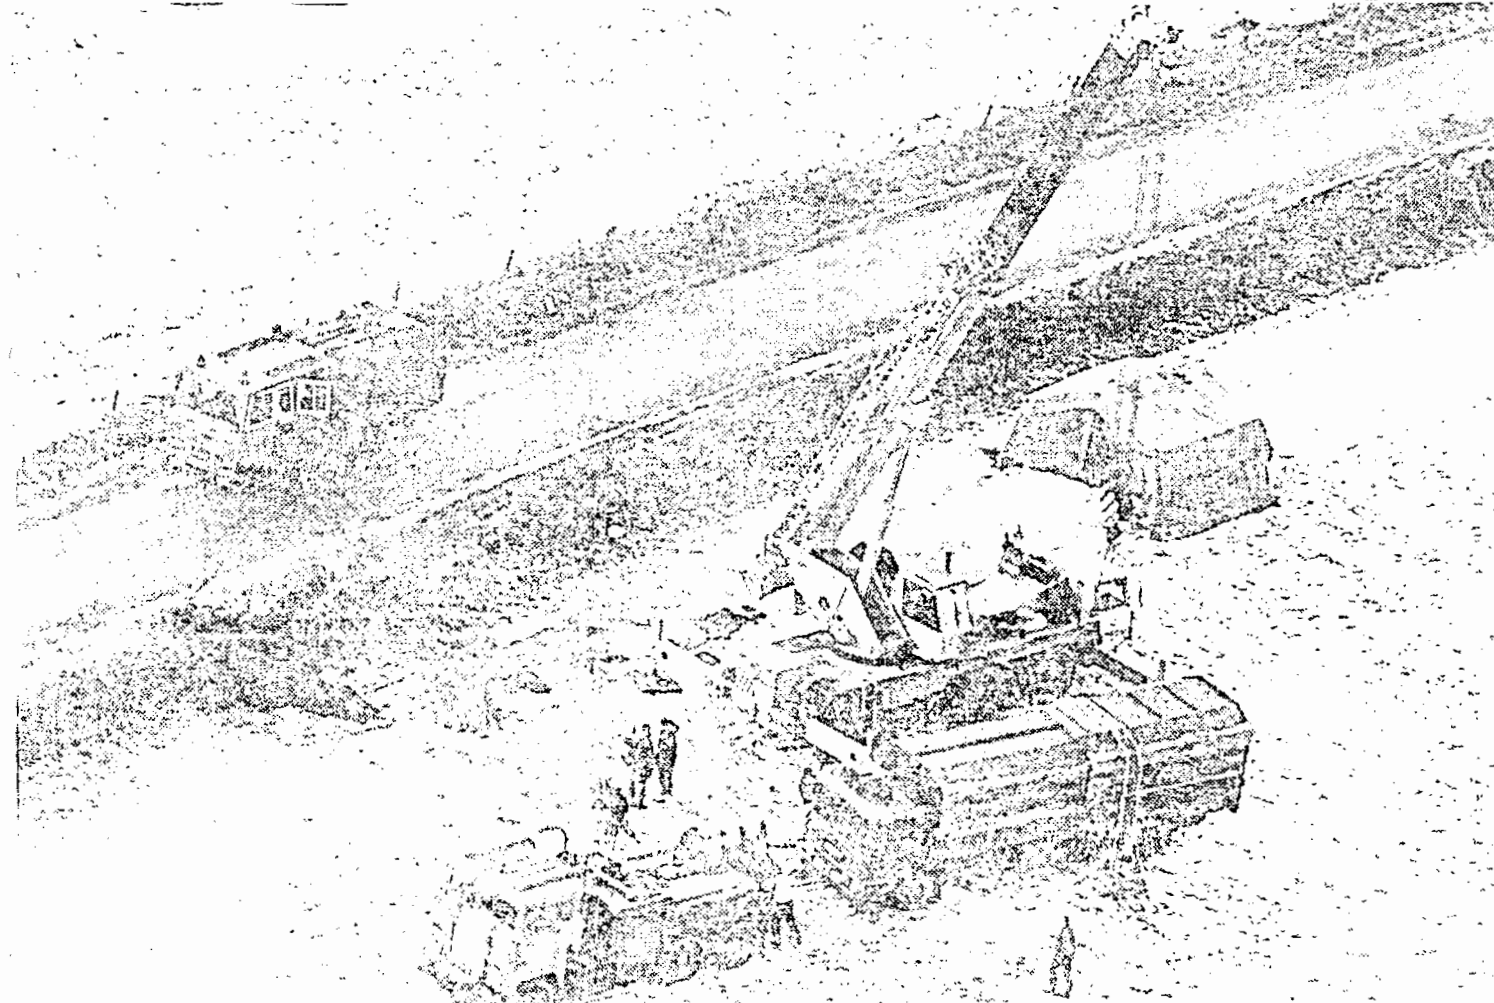
al shot of the accident scene yesterday, after the weapons container, a Mammoth Major, had finally been righted. (Photograph: John Ma)
