Forensic Assessments of the Nuclear Propulsion Plants of the Submarines HMS *Tireless* and RF Northern Fleet *Kursk*

John H Large
Large & Associates, Consulting Engineers

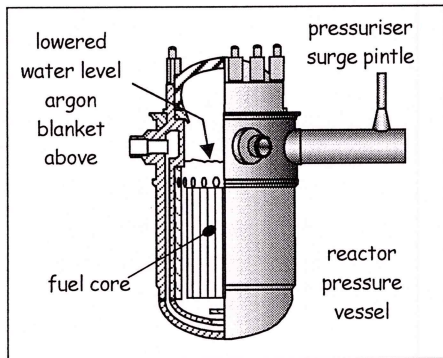
The fault in the reactor primary circuit of *Tireless* was first detected by the *leak-before-break* systems on board the submarine when she was submerged. The leak was located in the immediate locality of the welded pintle tee-junction of the pressuriser surge pipe and the main outlet pipe feeding from the reactor to one of the steam generators. The reactor was shut down following prescribed procedures, and the leakage rate estimated. It was then decided at high level within Ministry of Defence (MoD) and communicated back to the boat that the reactor could be restarted and the boat continue nuclear operations. However, after a few hours of running the leakage

If the fault had been allowed to develop further then *Tireless* would have been at very real risk of catastrophic failure of the surge pipe junction which, being located inboard of the primary circuit isolation valves, could allow the reactor pressure vessel to rapidly depressurise and starve of coolant. Uncontrolled loss of coolant at this locality could have resulted in boiling of the coolant remaining in the reactor vessel, overheating of the nuclear fuel (even with the nuclear process shut down because of the continuing residual heat from fuel decay), the possibility of fuel melting and, in the extreme, a violent explosion leading to a radioactive release within a few minutes.^{2,3}

5 RPV and Surge Pipe Pintle

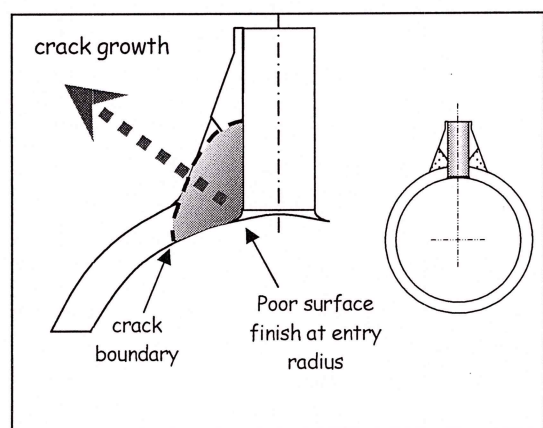
In fact, throughout this cool down and preparatory period the assumption had been that the fault was a single crack originating and confined within the pintle weld, that had grown from a flaw overlooked in the original build NDE radiographed certification of the weld and, importantly, that for the repair it would be sufficient to remove and replace just the pintle of the smaller diameter pressuriser surge pipe. However, once access for an in-pipe cctv viewing system had been established, the cracking was discovered to be very much more extensive, comprising two distinct centimetres long vertical fractures originating in the parent metal of the larger primary circuit pipework, and spreading upwards and outwards into the wall of the main pipe and pintle weld. The extent of the cracking required approximately one-quarter of the uppermost section of the primary circuit pipe at

6 Pressuriser Surge Line Pintle showing 1 of 2 thermally induced cracks

CNNRP concluded upon fuller inspection of the removed trepanned section, the cracking to have arisen from thermal fatigue resulting from slugs of cooler water cycling in and out of the mouth of the pressuriser surge pipe⁸ over many years of operation, although the final detailed results of the analysis of the removed pintle-main pipe section were never revealed to the Expert Panel advising the Government of Gibraltar.⁹ In the absence of proof otherwise, it may have been that the failure cause was more complex, resulting from a combination of thermal fatigue¹⁰ and thermal striping,^{11,12} the latter being relatively short-term in development. Another possible contributory factor to the cracking was the very poor (grooved) finish of what should have been a smooth, radius edge of the main pipe cut-out leading into the surge pipe, possibly containing latent crack initiators that could have developed over years of service.

Working up the new repair plan and the decision to replace the pintle design with a one-piece forged swept branch connector (a *Sweepolet*) further delayed progress on *Tireless* until November, thereafter there was stay-over whilst another *Trafalgar* class submarine was adopted as the lead boat to demonstrate the ease and validity of repair at the fully equipped Devonport Dockyard in the UK. *Tireless* was eventually fitted with the *Sweepolet*, passed NDE and the cold hydro test, being readied for nuclear power operations to leave the Port of Gibraltar on 8 May 2001, almost a year to the day that she ignominiously limped into Gibraltar under her emergency diesel power.

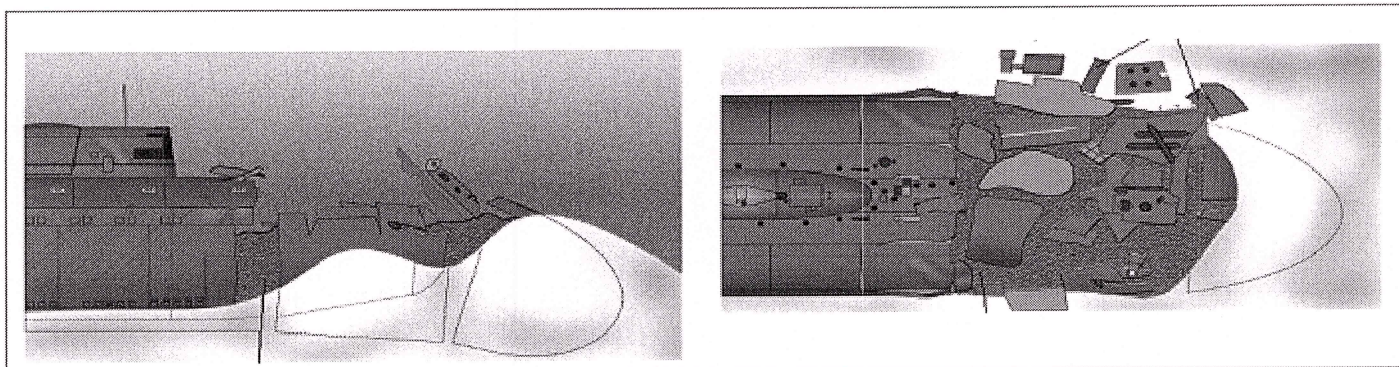
forward pressure hull (10 x 8m area) and outer casing and, at the same time, sending a reverberating hammer blow through the compartments towards the stern. Structural and flood bulkheads N° 2 and 3 were ripped through, with N° 4 buckling and subsequently collapsing under the hydrostatic flooding loads. N° 5, the forward reactor compartment bulkhead, and the remaining bulkheads through to the ninth compartment remained intact.¹⁵

7 Wreck of the *Kursk* – bow flood hull housing the forward seeking sonar has been displaced, the various cylinders are gas storage bottles, and the entire top section of the pressure hull of No 1 and No 2 compartments has been blown away

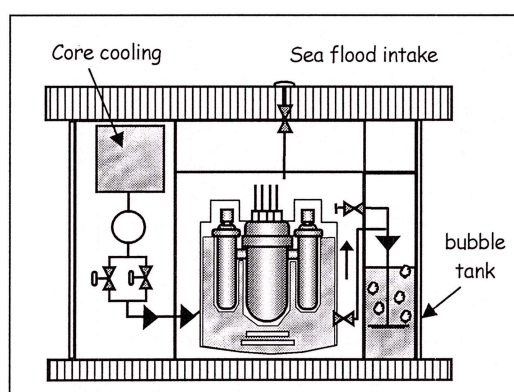
8 Integrated PWR plant (1 of 2) in Compartment No 6 showing schematic of emergency cooling systems

First, the capacity of the passive heat dissipation and emergency core cooling systems to protect the reactor cores was assessed.¹⁹ Observations for the range ship *Pyotr Velikiy* gave *Kursk* to be making a little over 6 knots on its torpedo run and, rigged in combat role, her reactors would have been powered to include for at least a 15% steam dump to the condensers, so all in all about 90MW_t for each reactor at the instant of boat electrical supplies being tripped out and, once and if this had been coped with, thereafter a residual heat of decay of about 10 to 15MW_t reducing (initially rapidly and then slowing over weeks) until equilibrium *thermal rollover* had been reached. The post-incident dissipation of the reactor core residual heat, with the reactors tripped and once that the turbines had spun down and the condensers lost vacuum, in the absence of any energised core cooling systems was considered to be the most challenging phase. This had been analysed by the Russian technicians earlier with the outcome suggesting that some parts of the fuel cores would have been unlikely to have survived the associated temperature excursions without damage. So with the condition of individual fuel element containments (cladding) doubtful but in the absence of any radioactivity emanating from within the reactor compartment, the assessment was that the pressure hull and bulkhead containment in the vicinity of the reactor compartment remained sound, with at least one other containment level (either the shield tank and/or primary circuit) intact.
