*AWE Aldermaston – HYDRUS*

**ARBORICULTURAL METHOD STATEMENT AND TREE  
PROTECTION PLANS**

MER-110-011438

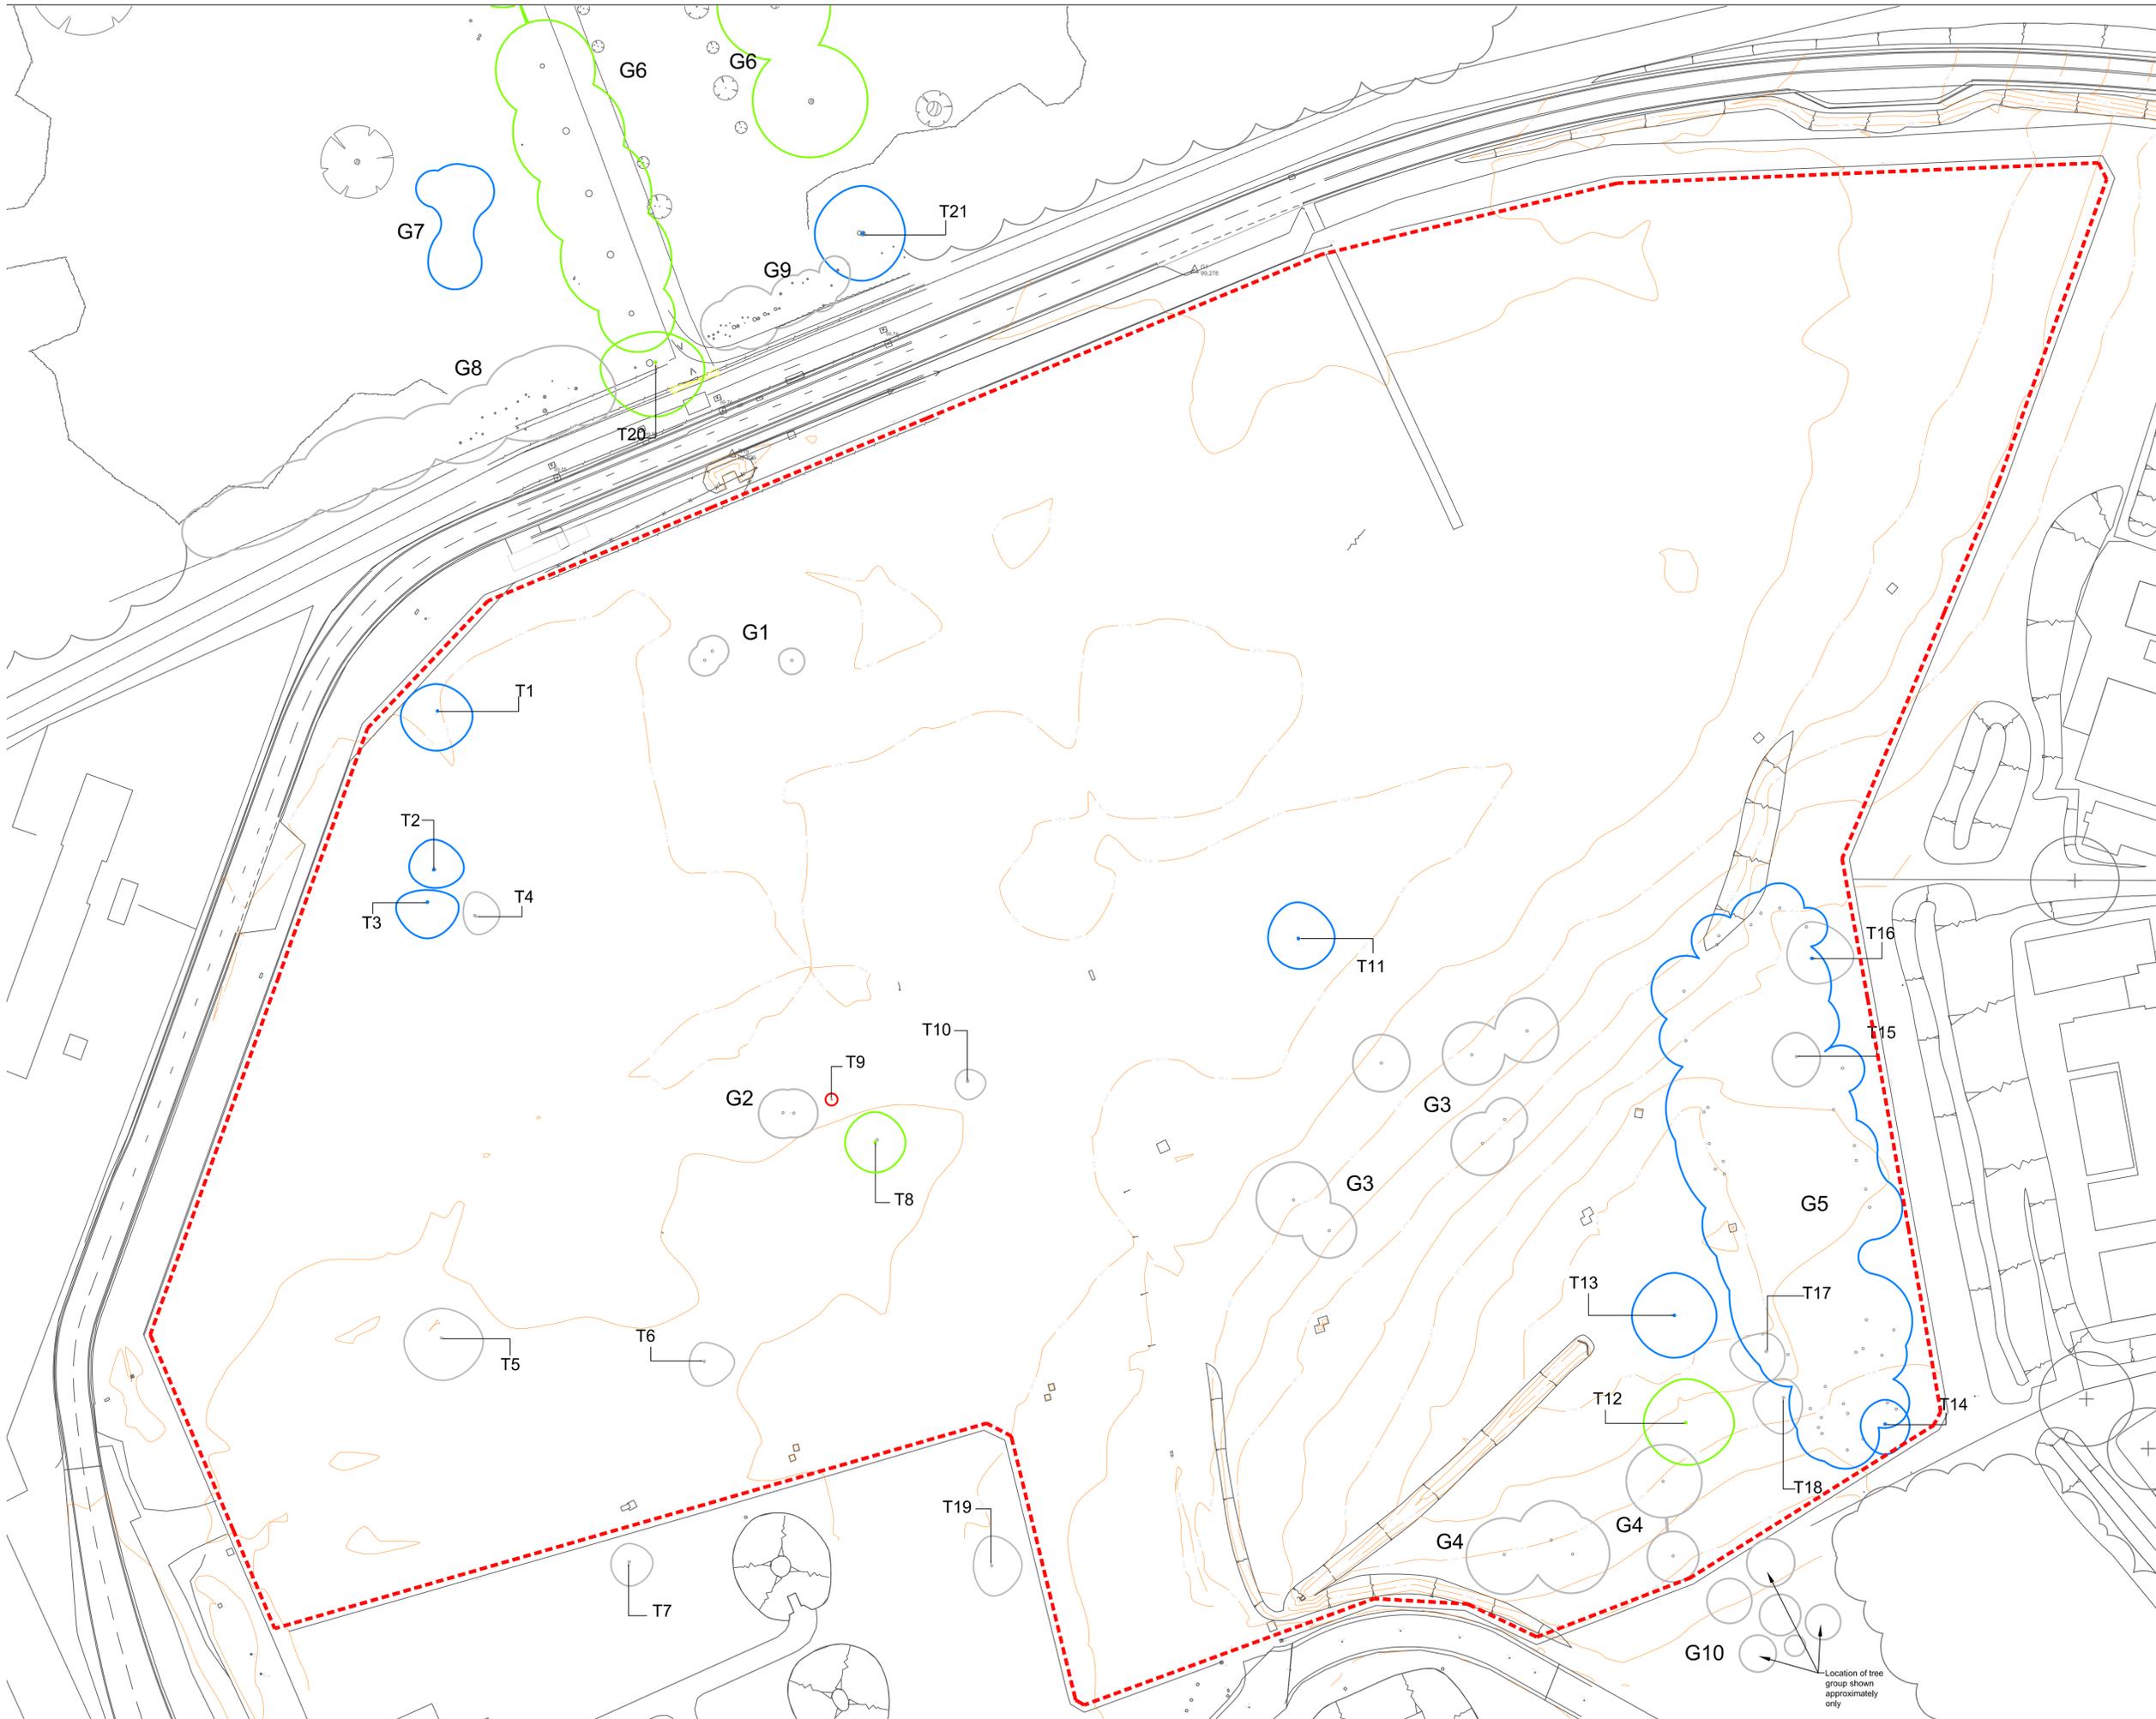
JSL1692\_001

- An initial Existing Amenity Vegetation Survey was undertaken by RPS on the 23<sup>rd</sup> of February 2009 followed by a supplementary survey noting the condition of the trees in full leaf made on the 6<sup>th</sup> of July 2009 (refer Appendix I). The survey covered the trees directly within the site boundary, on or near the boundary and in the broad visual realm of the proposed re-development works at Hydrus, AWE, Aldermaston. The survey noted that the trees are of mixed age structure arranged in small groupings with the occasional solitary specimen and consist predominantly native species. In the main the trees appear to be in reasonable general health.

- The tree survey identified a large veteran Oak tree in the south of the site as having high amenity value. Any works to this tree should be made in consideration of the planning guidance Planning Policy Statement 9: Biodiversity and Geological Conservation which notes that veteran trees have value for biodiversity.

- A number of trees and tree groups of moderate quality and value were identified and accordingly graded with an amenity value of category 'B'. This consisted, most notably of the wooded belt on the south-east corner of the site (G5), the three Oaks (T1-3) adjacent the north west boundary and the large plane (T13) directly to the north of the veteran Oak. The survey also identified a number of trees of low quality and value primarily the short lived Birch trees and any trees in poor general health (G3-4).

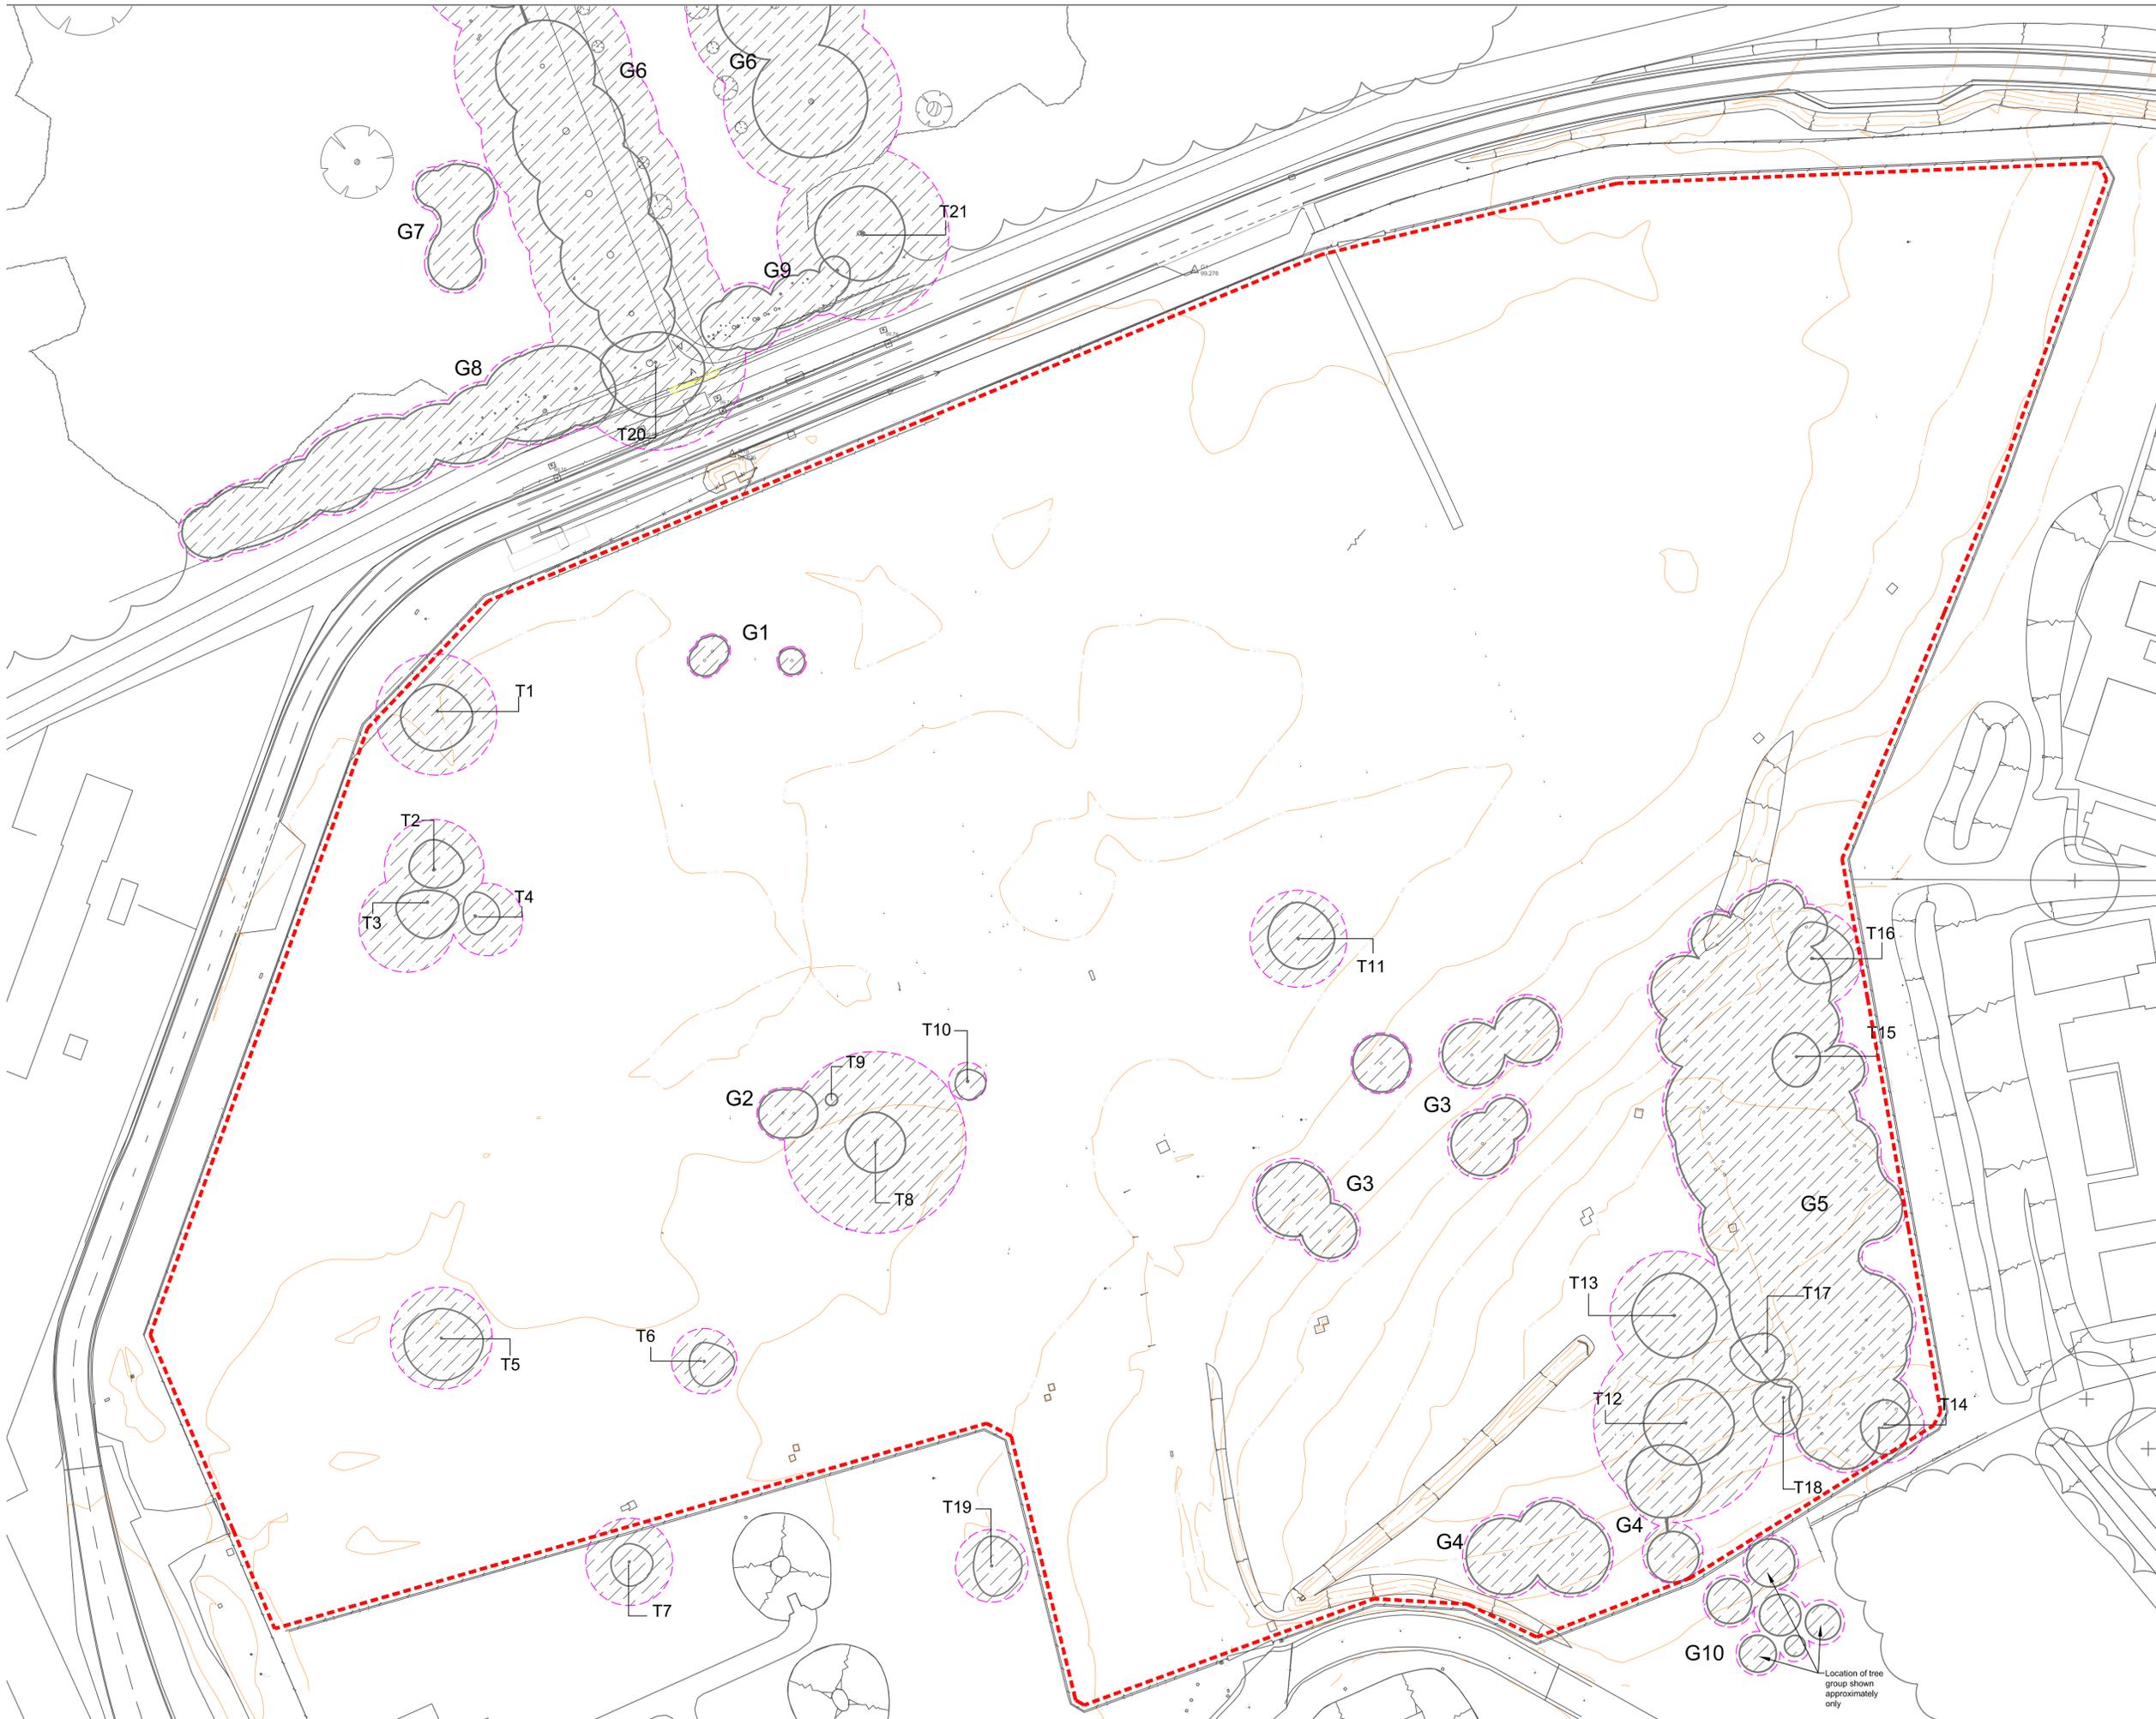
- 1.3 The Tree Constraints Plan JSL1692\_002 identifies the following:
- Canopy spread
  - Root Protection Area (RPA) of the trees
- 1.4 The Tree Removal and Protection Plan JSL1692\_003 identifies the following:

- 3.1 The RPA roughly equates to the spread of a tree canopy or an area equivalent to a radius approximately 12 times the stem diameter of the tree at 1.5m above ground level, whichever is the greatest. Where possible this area should be fenced-off and protected in accordance with BS5837: 2005. The canopy of the tree is likewise susceptible to damage during construction work and requires similar protection.

- 3.4 The extent of tree protection fencing is shown on the attached plan JSL1692\_002. The tree protection fencing shall be inspected and monitored during the course of the construction works, to ensure its compliance with the Tree Removal and Protection Plan JSL1692\_003.
