## Land Quality Assessment Desktop Study Report

### Land Surrounding Buildings 8F2 and 8F3B

AWE plc

JER3996/8S8F/LQA/DTS  
Revision: 0  
December 2008

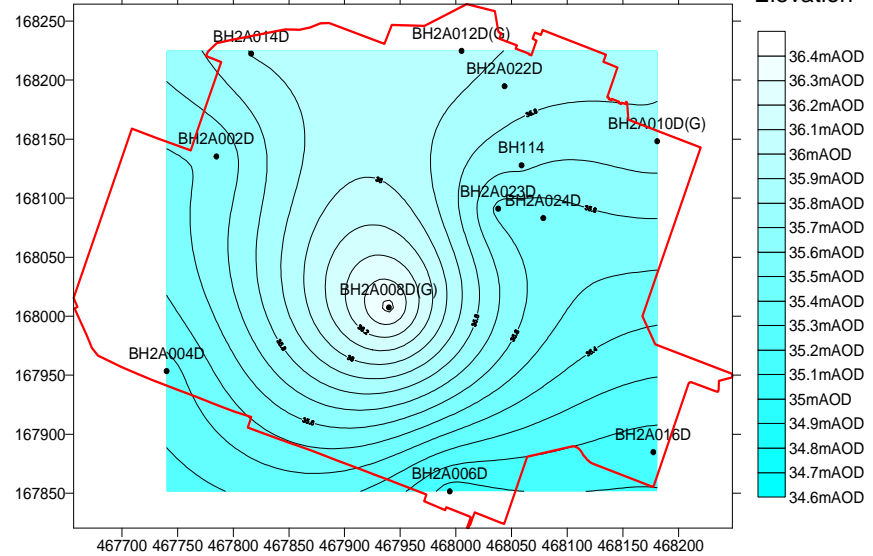
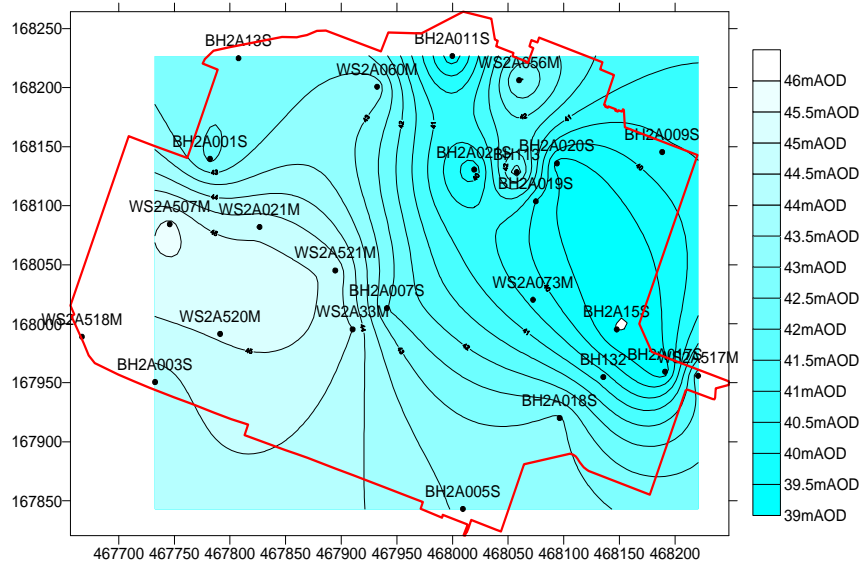
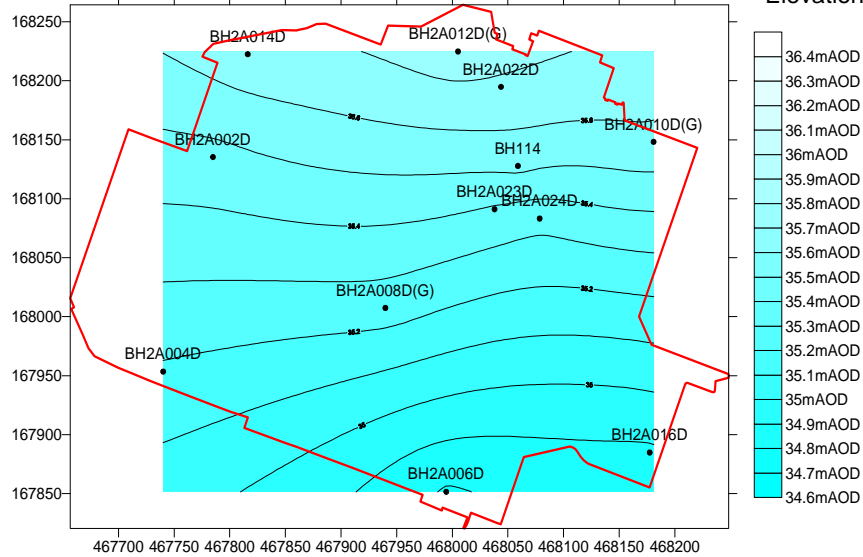
## Shallow Aquifer

### Groundwater Elevation

## Deep Aquifer

Groundwater Elevation

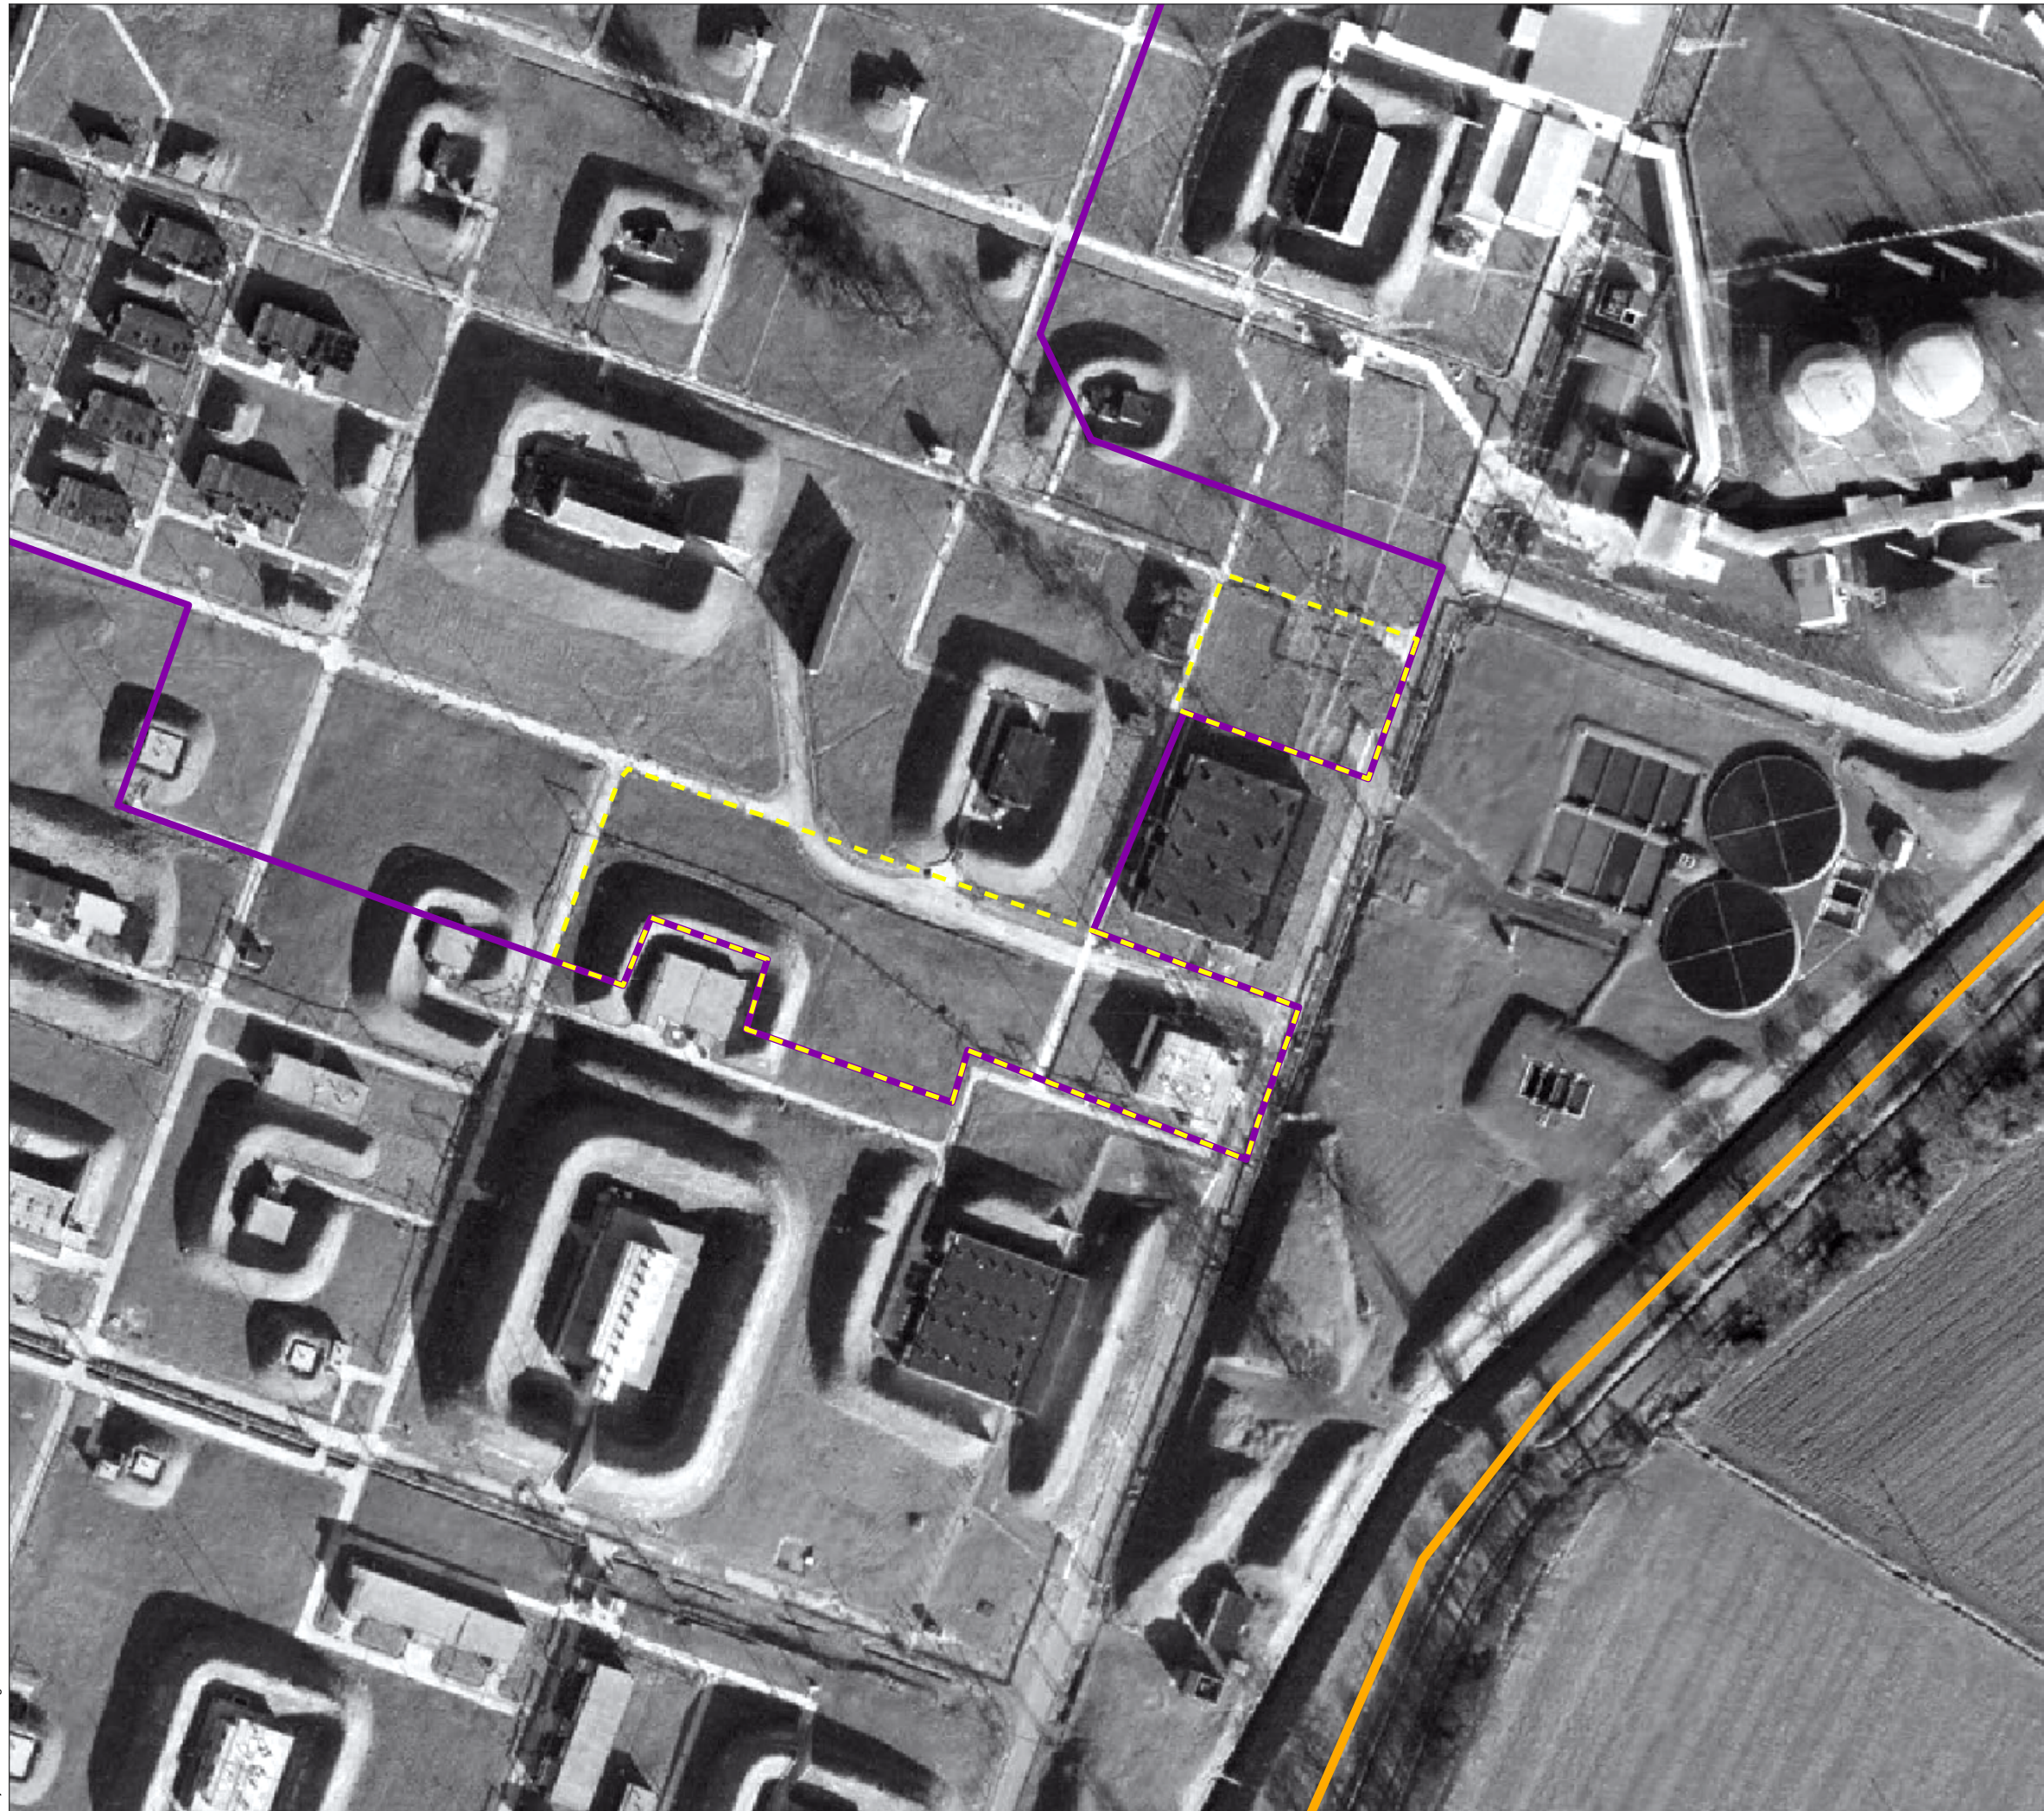
■ Figure No: **JER3996-8F-1964** Revision: -

### **Historic Aerial Photographs**
