ENGINEERING - TECHNICAL INVESTIGATION REPORT

Temperature Excursion on [REDACTED] Facility [REDACTED]

Technical Investigation Report Number: [REDACTED] REP/FDA/102

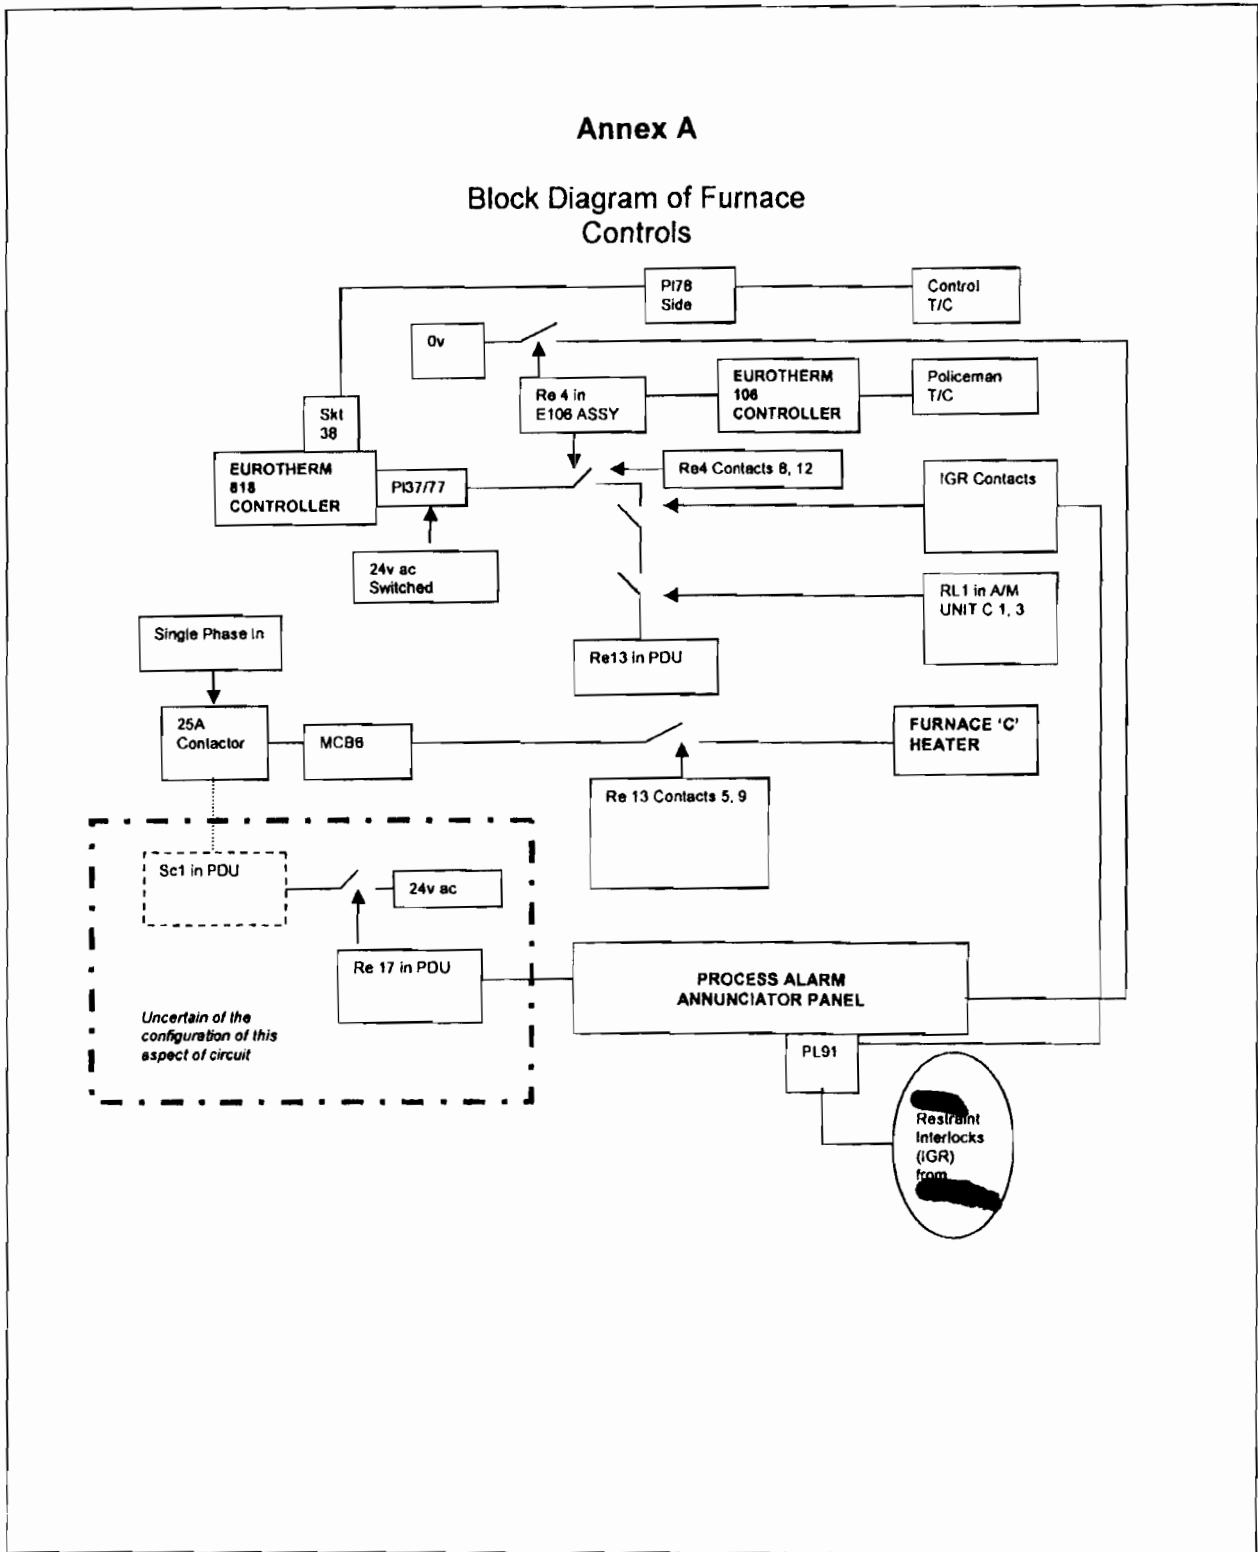
The casing from the original Relay 13 taken from furnace C was removed. It was observed that on the normally open contact the metal pad had completely been eroded and deposited on the common contact. The state of the contacts and relay casing confirm that arcing had taken place between the contacts. As the contacts deteriorate there is a high possibility of their correct operation becoming impaired leading to temporary fusing of them. (See Annex B Photograph 2)

There is no separate control path between the furnace temperature control and furnace over temperature protection. After replacement of Relay 13 all control systems operated as designed. On the removed Relay 13, contact pair 5 & 9 are significantly eroded away. A failure of Relay 13, contacts 5 & 9 to open when the coil is de-energised will cause the furnace heating element to be continually supplied with power. Relay 13 is a single point of failure with IGR's, Guard [REDACTED] Policeman Thermocouple and Temperature Control all using the same contact pair (5 & 9).

Even if no modification work to rectify short-falls was planned, both the B furnace heater relay and the relay used for this investigation show signs of blackening on their cases and would require replacement prior to a return to service.
