Reference: SDE/PFG/105/07
Copy No. 2 of 20 Copies
Page No. 1 of 18 Pages
16 January 1987

TCHD ACCIDENT - WEST DEAN, 10.1.87

AWRE View

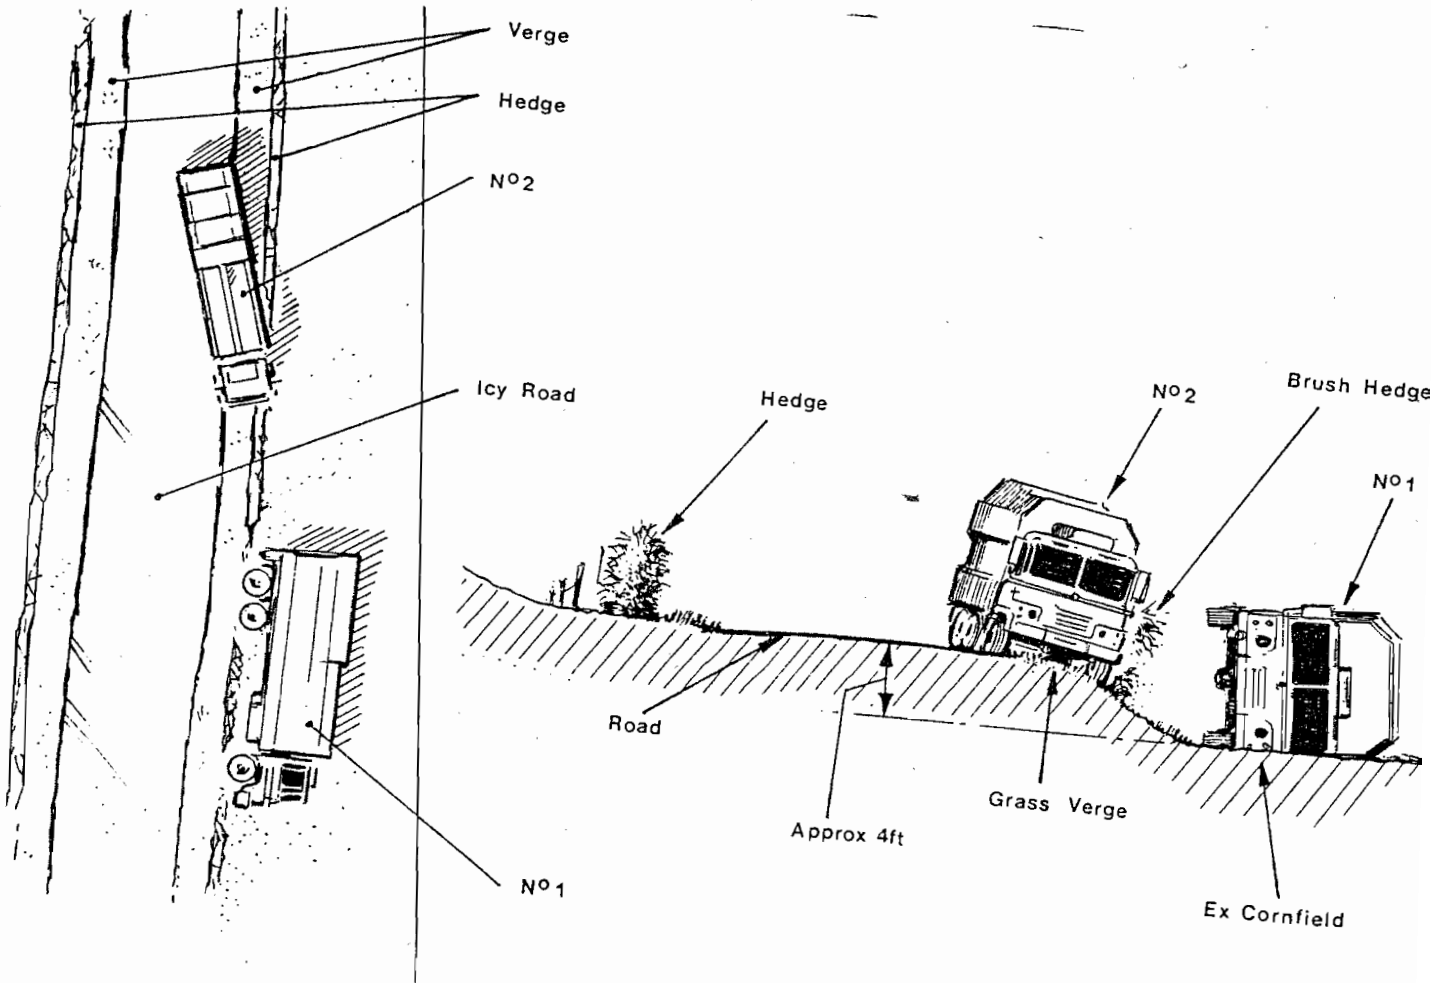
Load Carrier No. 1 on its near side in what had previously been a cornfield and was now stubble and frozen. Load Carrier No. 2 upright with its near side rear wheels on the grass verge and both its front wheels off the road and 'grounded' on its front axle area.
